NBSIR 73-105

Environmental Evaluation of Polyurethane Foam Core Sandwich Panel Construction

Final Report

Prepared for
Office of Research and Technology
Department of Housing and Urban Development
Washington, D. C. 20410

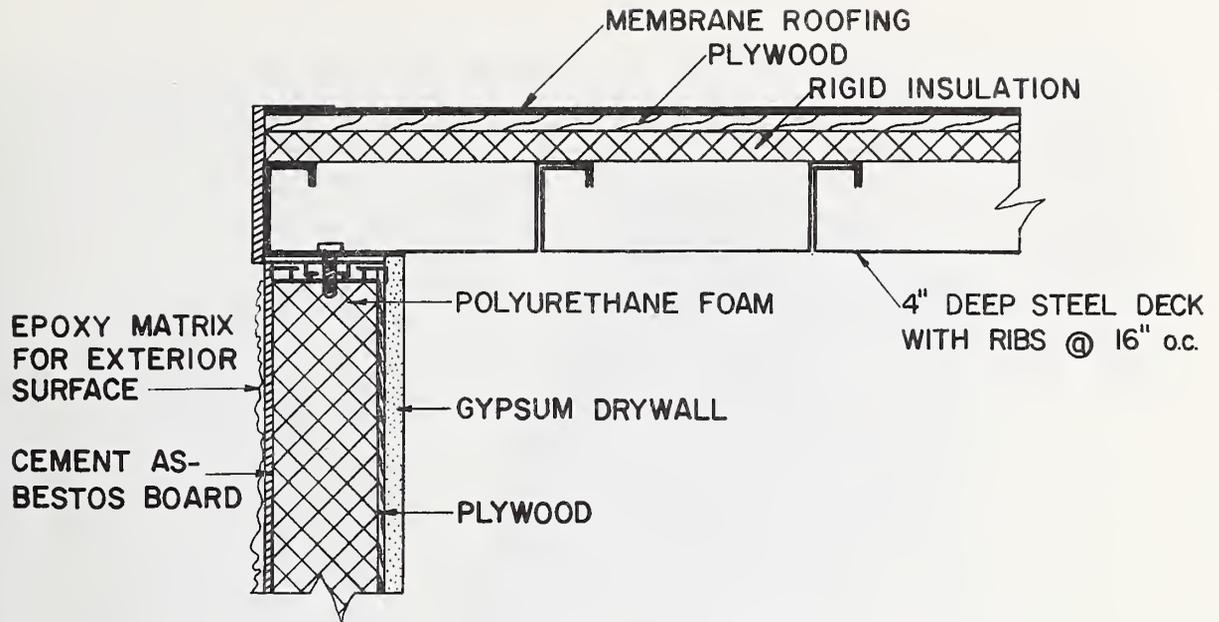
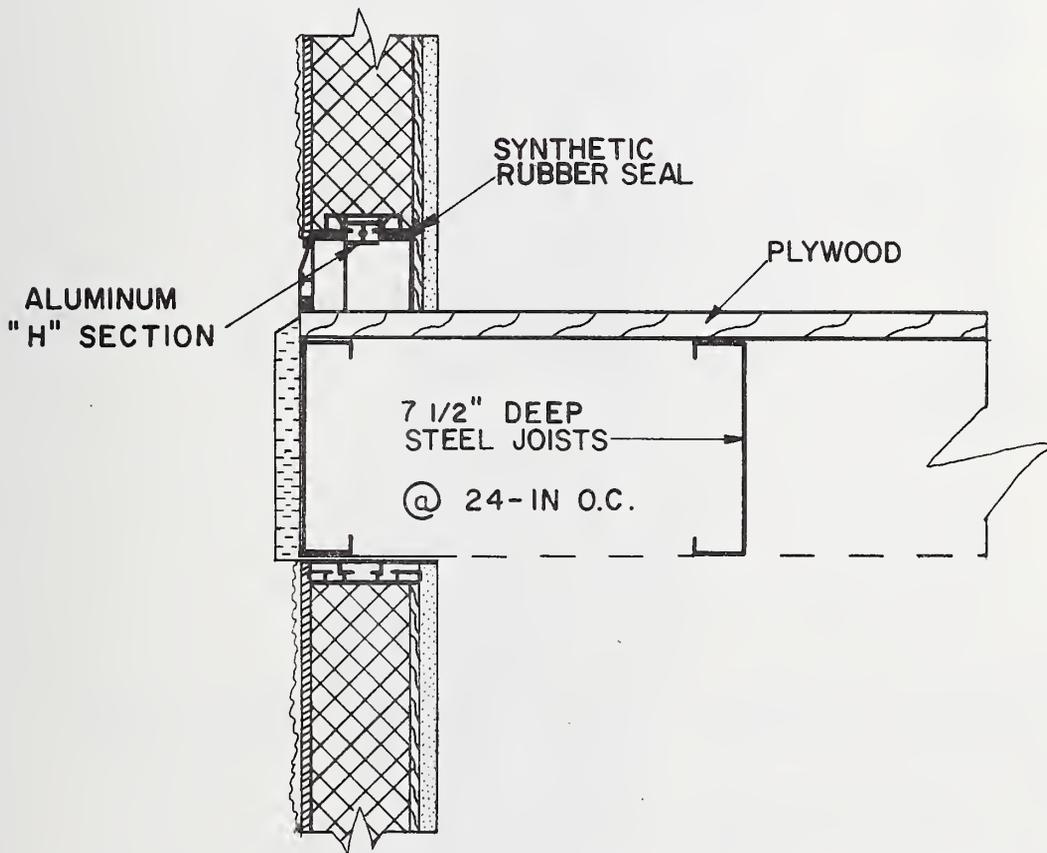
a. ROOF WITH CONNECTED WALL

b. FLOOR WITH CONNECTED WALLS

FIGURE 1. STRUCTURAL COMPONENTS OF HOUSING SYSTEM

"Operation BREAKTHROUGH," a program sponsored by the Department of Housing and Urban Development, has encouraged the production of some new structural concepts in manufactured housing systems. One of the proposed systems has as its basic structural components a steel joist floor construction; a composite steel deck construction for the roof; and a sandwich panel system for use as bearing walls as shown in figure 1. Steel joists 24-in on center with a 3/4-in plywood sub-flooring is used in the floor construction. The composite roof is constructed by covering the steel roof deck with 1-in rigid insulation board overlaid with 1/2-in plywood. The proposed panel system for the bearing walls consists of 4-ft by 8-ft by 3-in panels of sandwich construction interlocked by an aluminum "H" section. The panels are fabricated by placing the face materials in a frame constructed with aluminum extrusions and filling, by a continuous process, the space between the faces with a polyurethane foam. The exterior face is 1/8-in cement-asbestos board covered with

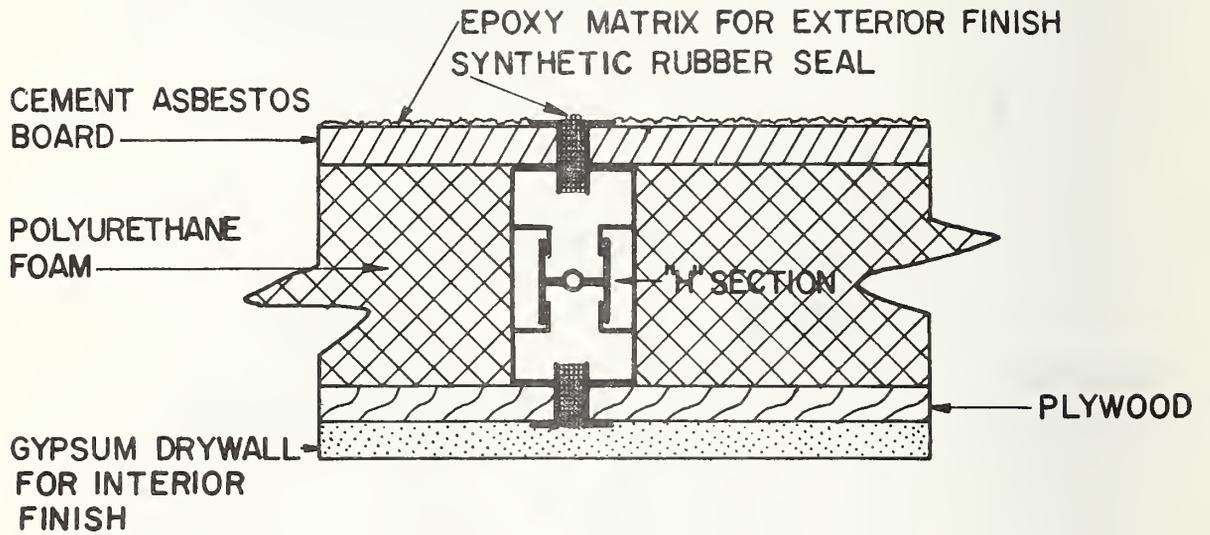
FIGURE 2. VERTICAL CONNECTION IN WALL PANEL SYSTEM

an epoxy adhesive for the attachment of decorative stone. Plywood, 1/4-in thick, is used for the interior face. The wall panels are connected to the floor by attaching matching aluminum extrusions to the plywood sub-flooring and then sliding an aluminum "H" section through the extrusions as shown in figure 1b. The wall panels are connected to the roof deck by inserting sheet metal screws through the steel deck and a matching aluminum extrusion as shown in figure 1a. The aluminum "H" section is used to form an interlocking vertical joint between the panels as shown in figure 2. A synthetic rubber seal is then inserted to fill gaps in the joint where an "H" section is used as the connector. After erection, the interior face of the panels is covered with gypsum drywall.

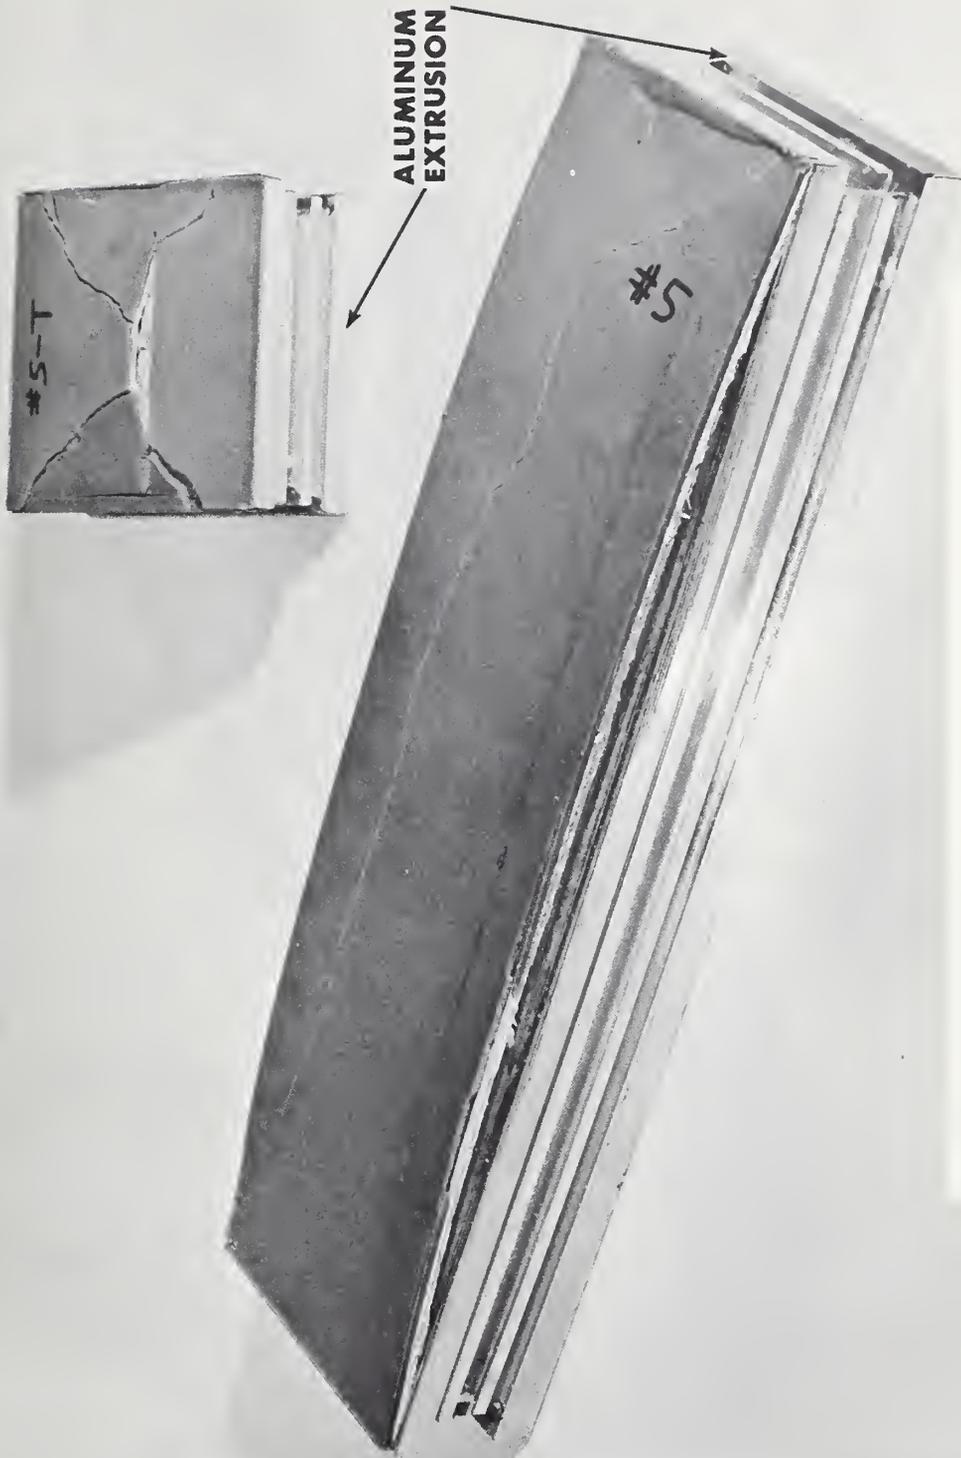
FIGURE 3. SPECIMENS FROM SAMPLE 1 AGED BY ASTM C-481
CYCLE A

All specimens of Sample 1 exhibited bowing and cracking of the cement-asbestos board facing. The bowing was noted in each specimen following the first dry heat step of the first cycle of the aging procedure. Cracking of the cement-asbestos board and the coating material had occurred in each specimen by the end of the second dry heat step of the first cycle. Figure 3 illustrates the type of failure that was observed. The bowing and cracking of the cement-asbestos board was caused by expansion of the foam core normal to the plane of the panel since expansion of the core either length-wise or width-wise was restrained by the aluminum perimeter extrusions. The accelerated aging procedure was stopped at the end of the first cycle when it was observed that all the specimens had suffered severe damage. Because of the severe damage the shear and flatwise strengths of the specimens were not obtained.

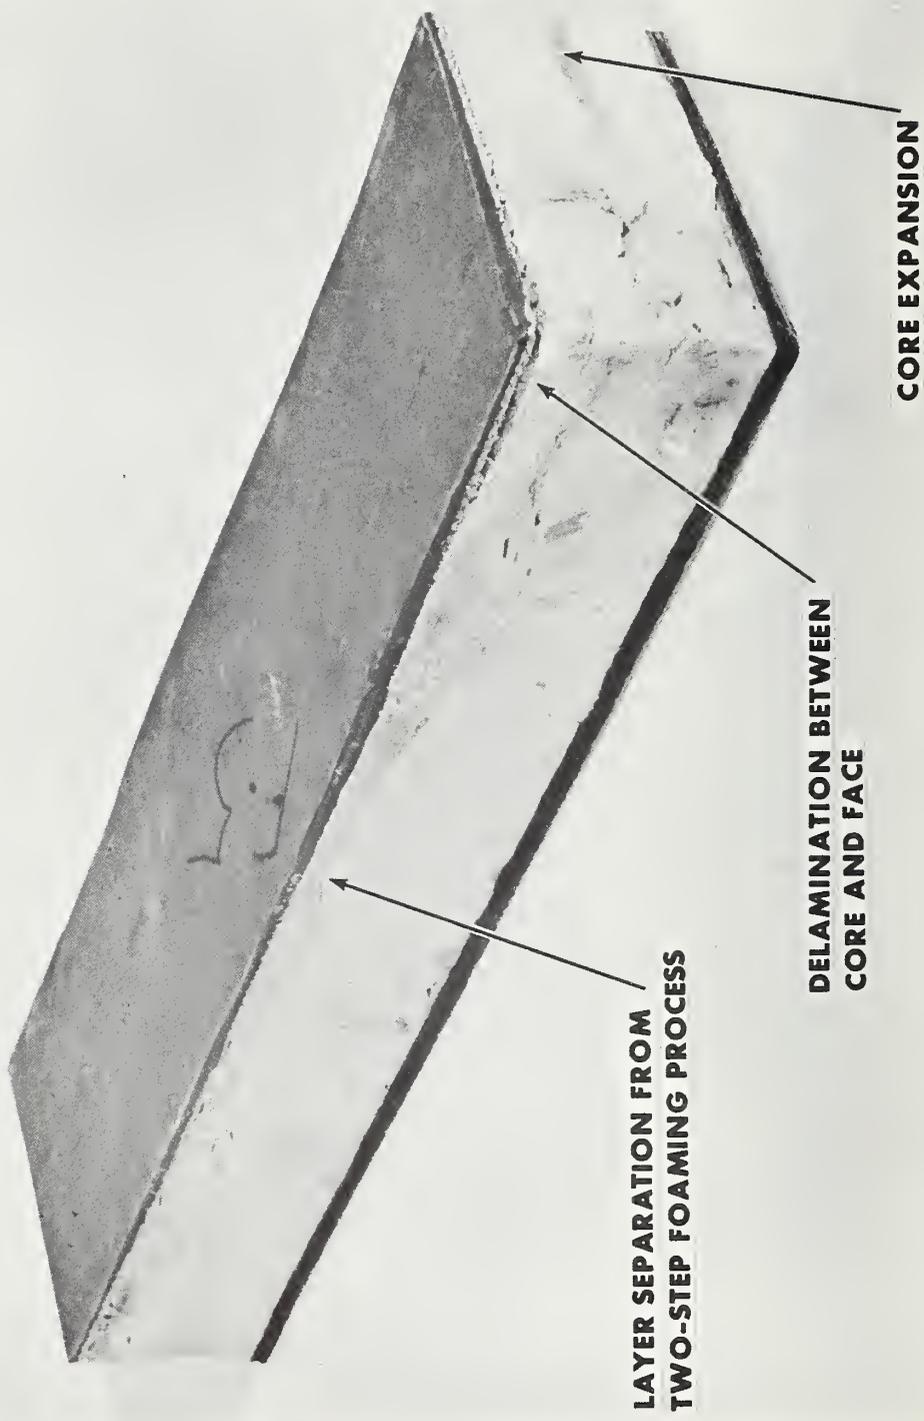
FIGURE 4. SPECIMEN FROM SAMPLE 2 AGED BY ASTM C-481.
CYCLE B

The first deterioration of Sample 2 specimens was noted following the first dry heat step of the first cycle in a 6 x 23 in specimen. The observed damage was a delamination of the cement-asbestos board from the polyurethane core. By the end of four cycles all specimens showed partial delamination of the cement-asbestos board from the core. Expansion of the core material occurred in each specimen and some specimens exhibited cracking within the polyurethane core. Figure 4 illustrates the delamination and cracking of the polyurethane core and also shows that the foaming process must have occurred in two steps. Much of the cracking in the core material was noted to be at the interface which was a result of the two step foaming process. Initial indication of damage or increased degradation of the specimens was observed following one of the dry heat steps in the cycle indicating that the elevated temperatures were the primary factor causing the foam expansion. Because visible damage had occurred in all specimens the accelerated aging procedure was stopped at the end of the fourth cycle. Again the damage was sufficient to preclude obtaining strength of the specimens in shear and flatwise-tension.

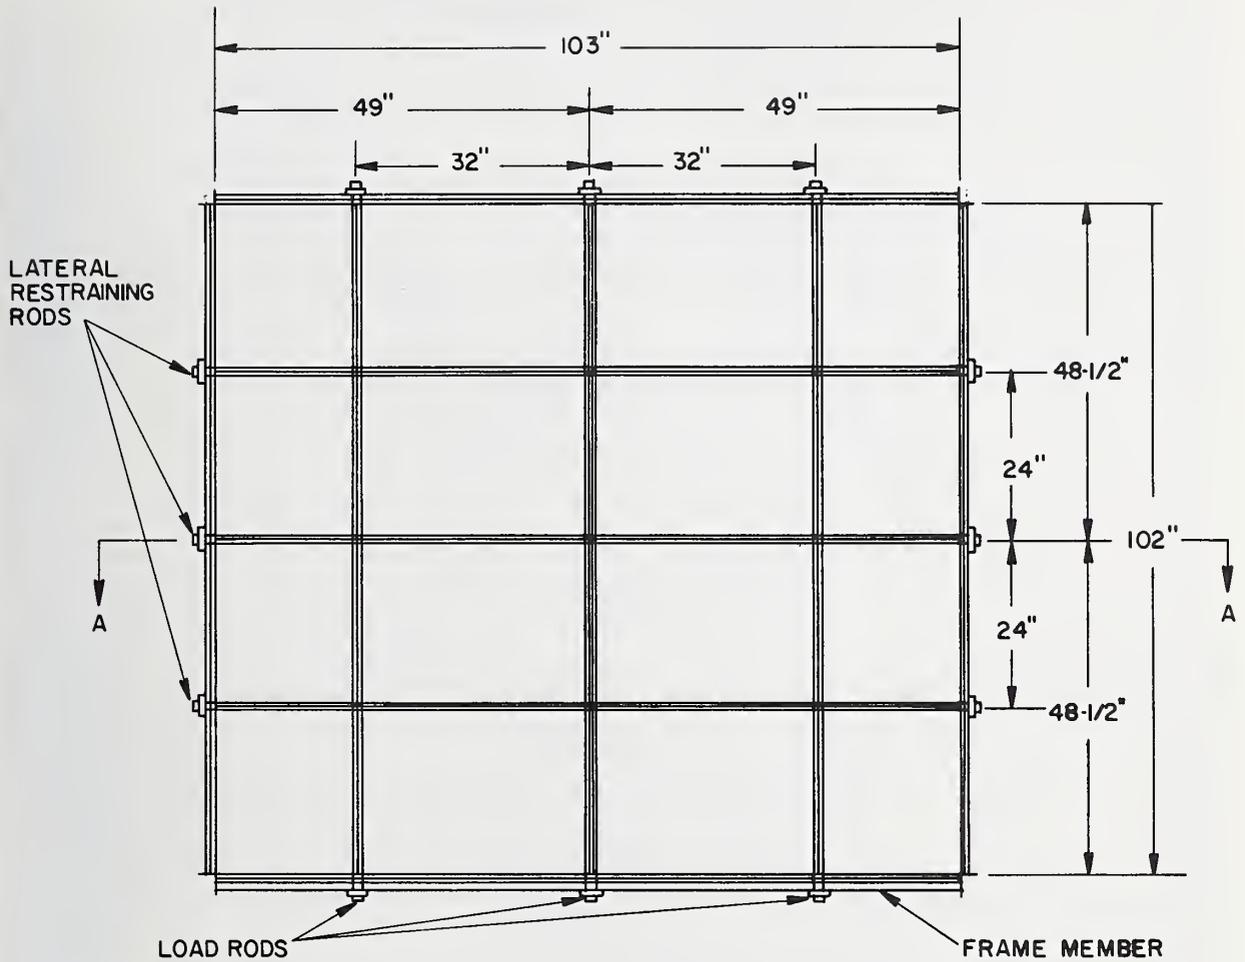
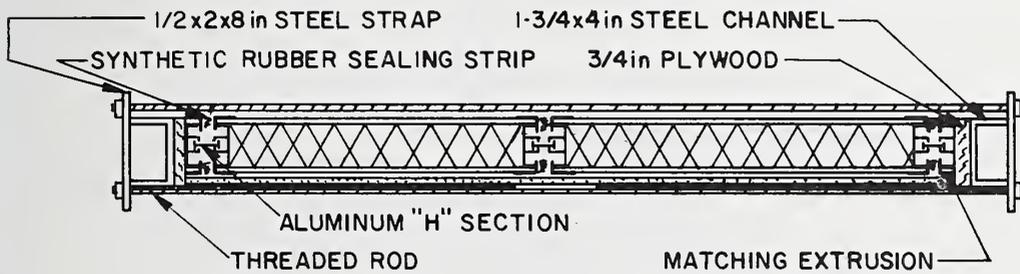
SECTION A-A

FIGURE 5. SCHEMATIC FOR ENVIRONMENTAL TEST WALL

The test specimen consisted of two 4- by 8-ft sandwich wall panels attached to a test frame by connection methods used in the housing system. The wall test segment is shown in figures 5, 6 and 7. Figure 8 shows construction details of the test specimen. The sides of the test frame were made by attaching 3/4-in plywood to a 1-3/4 x 4-in steel channel with wood screws. The appropriate matching wall extrusions were then connected to the plywood with sheet metal screws. The wall panels were connected to the extrusions on the frame by "H" sections in a manner prescribed by the manufacturer with rubber sealing strips inserted along all vertical connections and along the base connection on both the interior and exterior sides of the panel. The face of the specimen, on the interior side, was covered completely with gypsum dry-wall in the manner prescribed by the system manufacturer. Threaded rods were placed horizontally across the specimen on both sides and attached to the steel channel on the side members of the frame at the quarter, mid, and three-quarter height to provide lateral support. A small amount of tension was introduced into the horizontal rods as the purpose of this horizontal restraint was to simulate the lateral restraint provided by adjacent panels in the actual structure. Threaded rods were attached vertically on both sides to the steel channel at the center and at 32-in offsets on either side of the center. The vertical rods were used to simulate the load

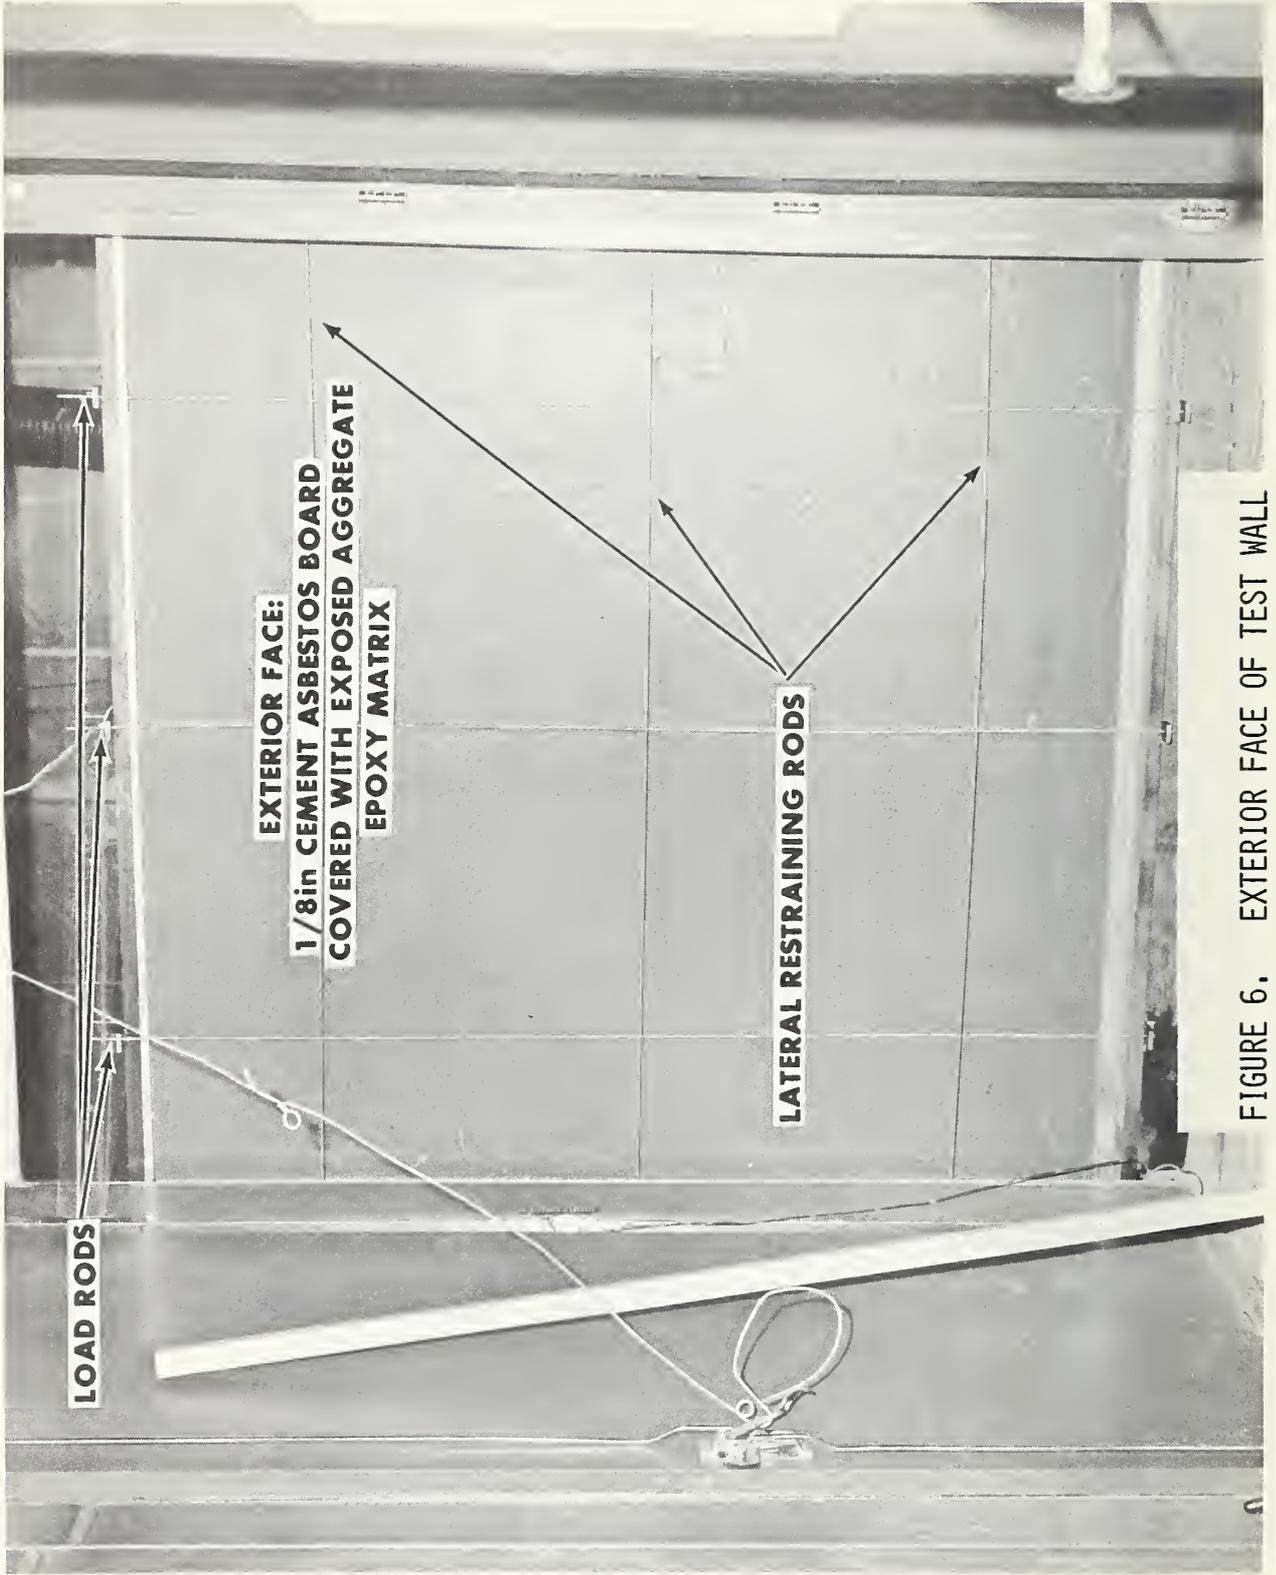
FIGURE 6. EXTERIOR FACE OF TEST WALL

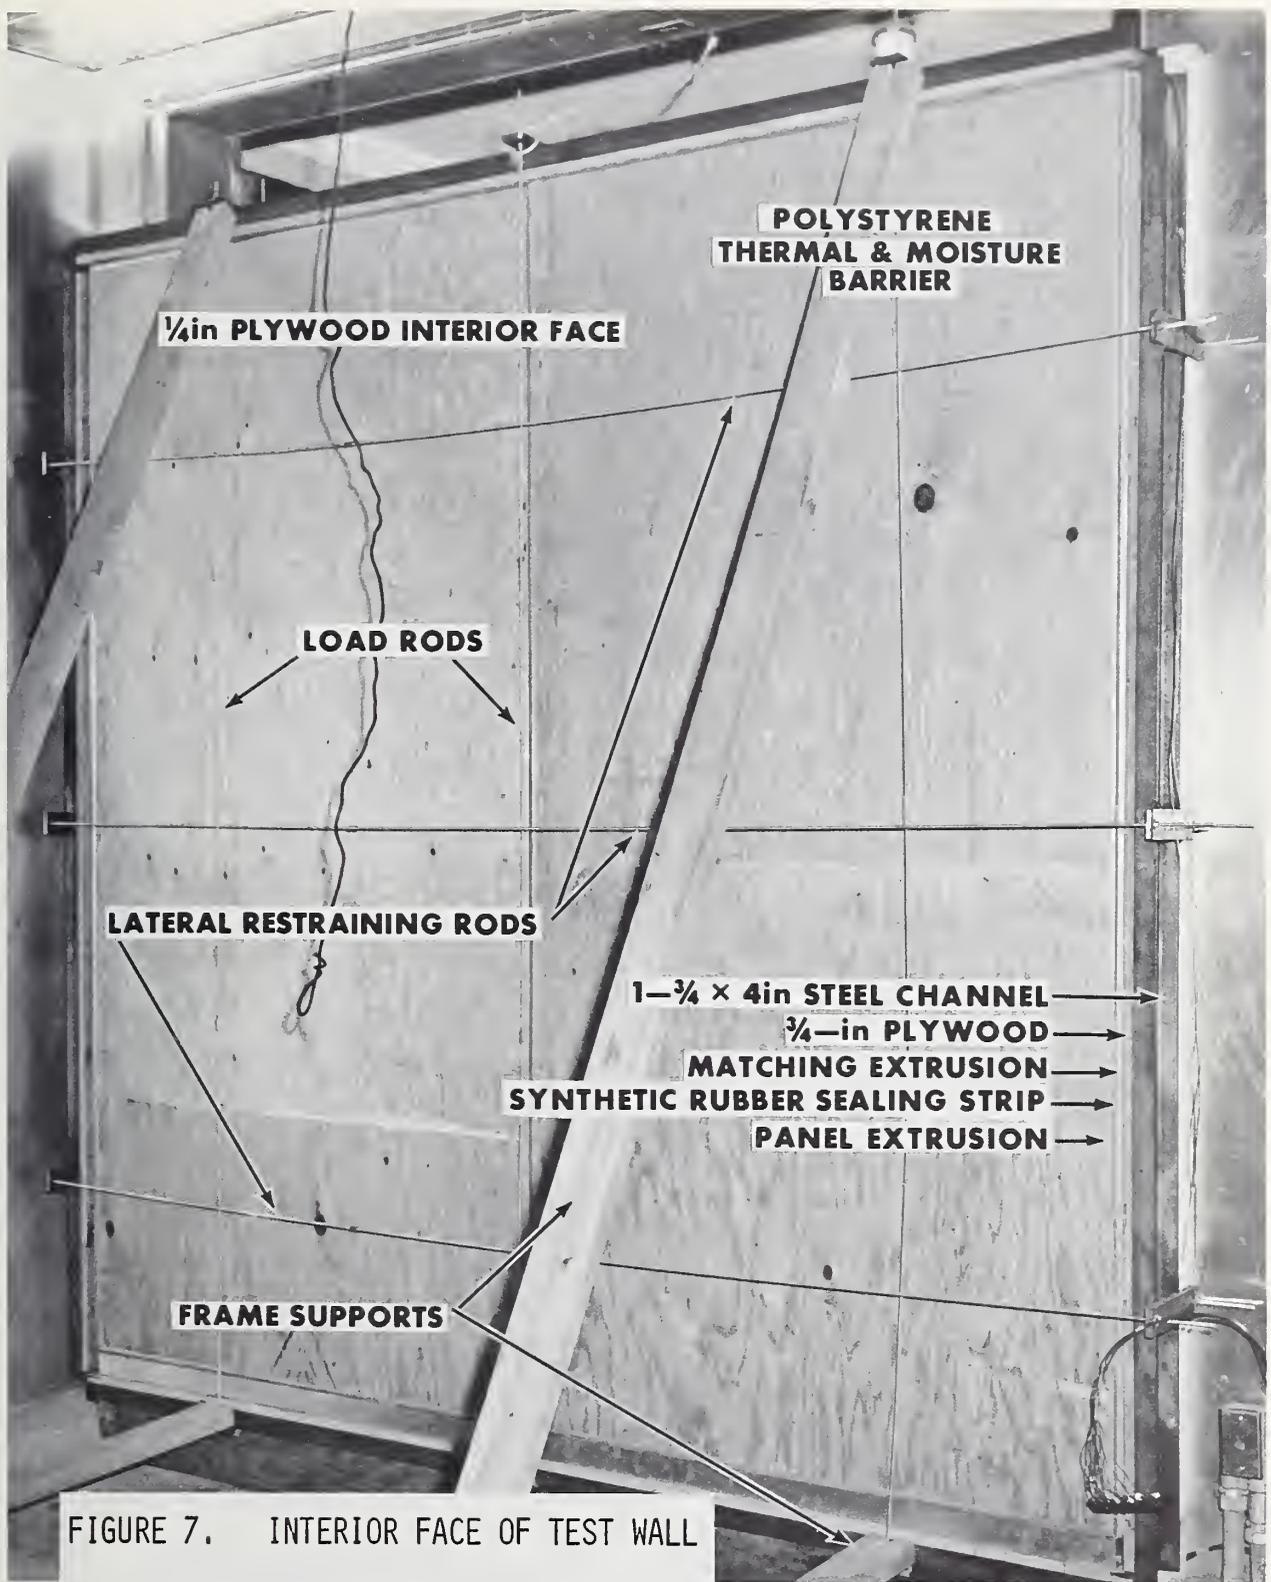
1/4in PLYWOOD INTERIOR FACE

**POLYSTYRENE
THERMAL & MOISTURE
BARRIER**

LOAD RODS

LATERAL RESTRAINING RODS

1-3/4 x 4in STEEL CHANNEL

3/4-in PLYWOOD

MATCHING EXTRUSION

SYNTHETIC RUBBER SEALING STRIP

PANEL EXTRUSION

FRAME SUPPORTS

FIGURE 7. INTERIOR FACE OF TEST WALL

FIGURE 8. DETAILS OF TEST WALL CONSTRUCTION

a floor and/or roof system would apply to the wall. Polystyrene insulation was placed around the test specimen in order to provide a thermal and moisture barrier between the two faces.

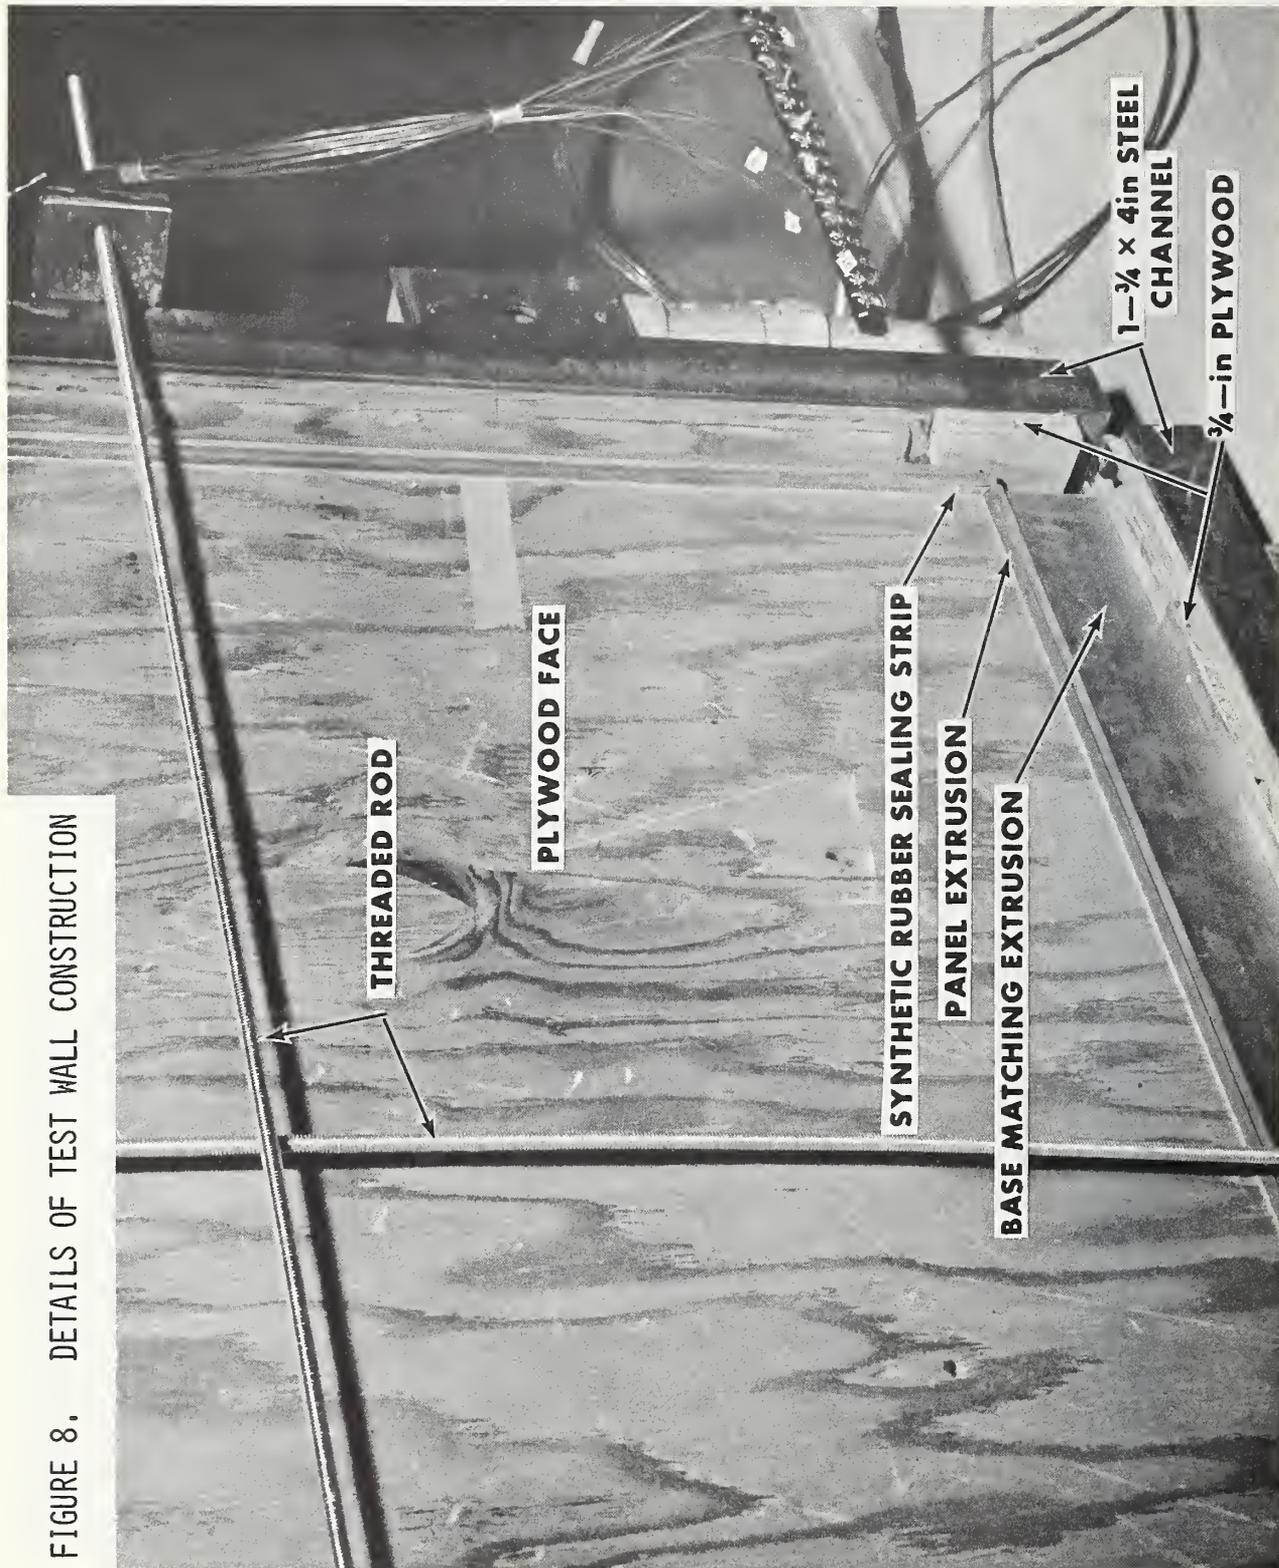
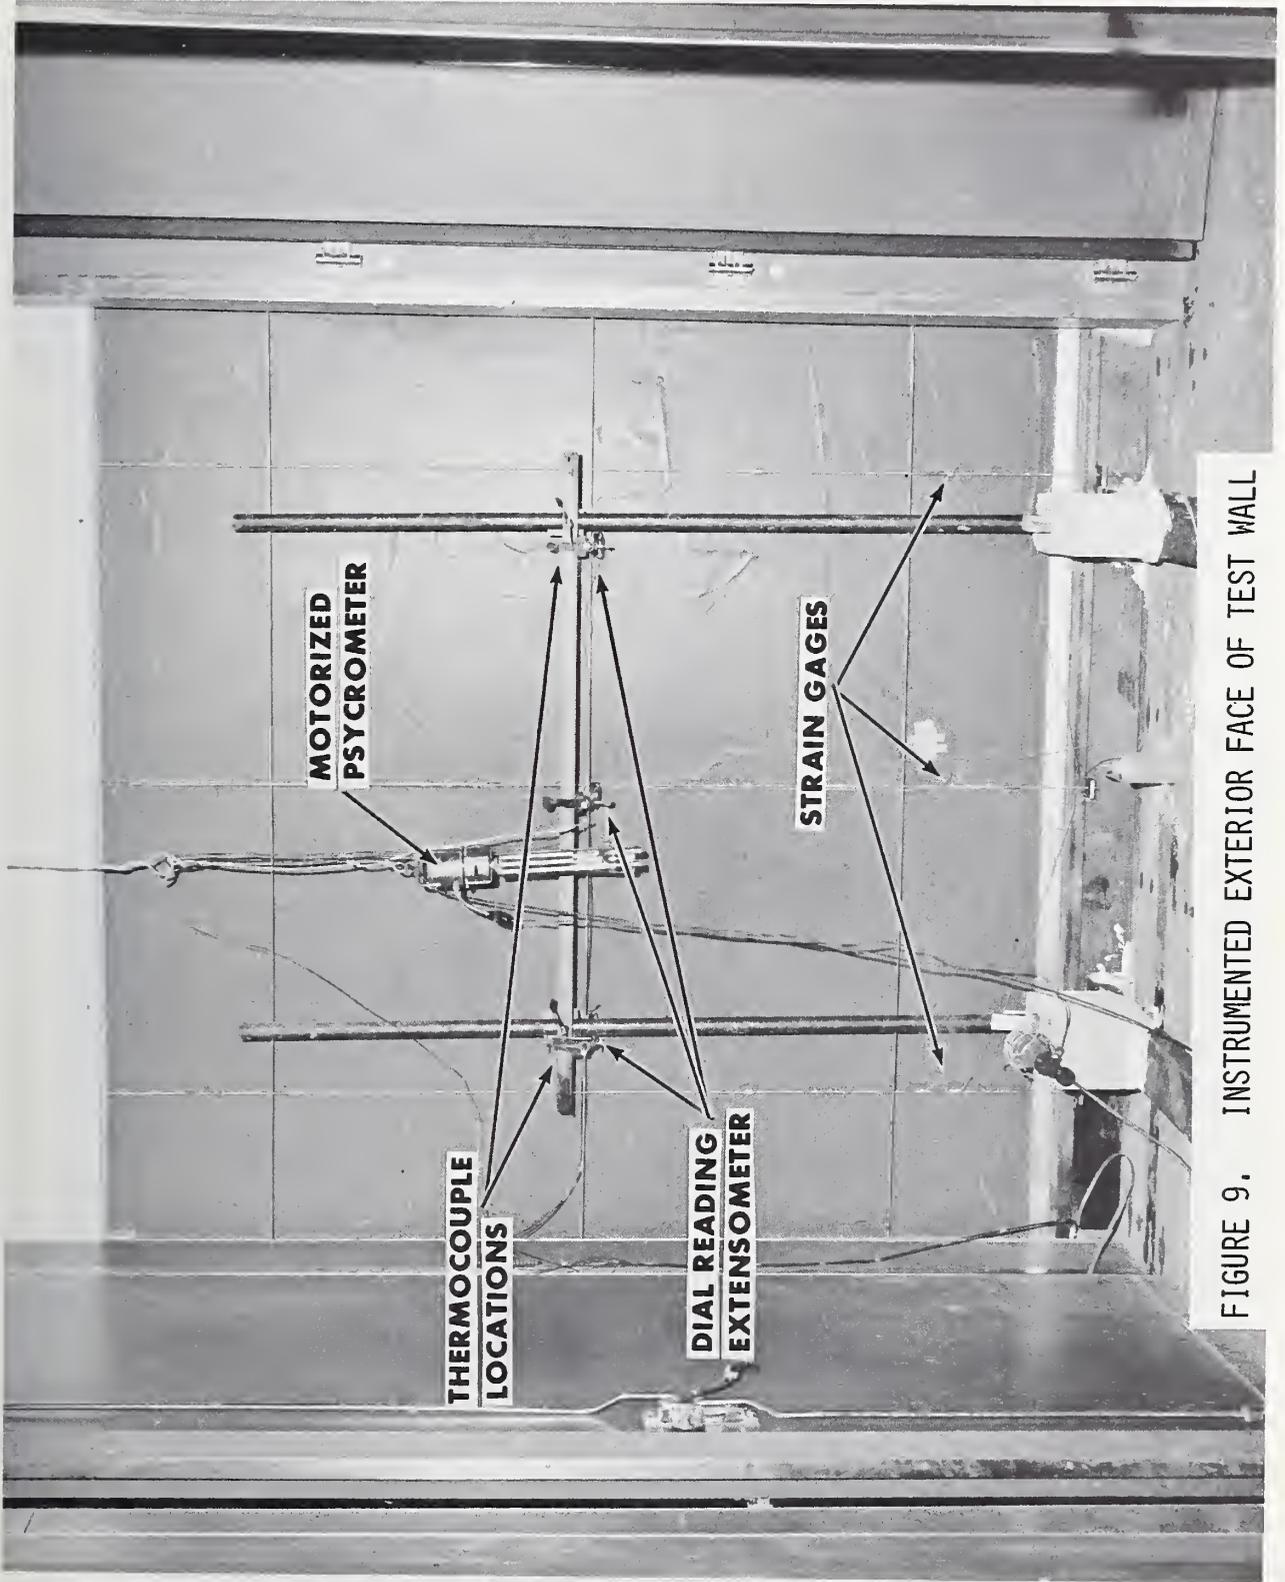
FIGURE 9. INSTRUMENTED EXTERIOR FACE OF TEST WALL

Eight dial gage extensometers were used during the test to measure the displacement of the wall test segment. All extensometers were located at midheight of the specimen as follows: 3 each on the interior and exterior faces at the center of the panels and test specimen; and 1 on each of the vertical frame members on the interior side. Strain gages were attached to the vertical rods so that the load applied to the wall by introducing tension in these rods could be monitored during the test. The temperature and humidity of the air on both sides of the test specimen were checked during the test by a motorized psychrometer. Thermocouples were attached to both sides of the specimen so that the face temperature of the wall could be continuously recorded during the test. The instrumentation is shown in figures 9 and 10.

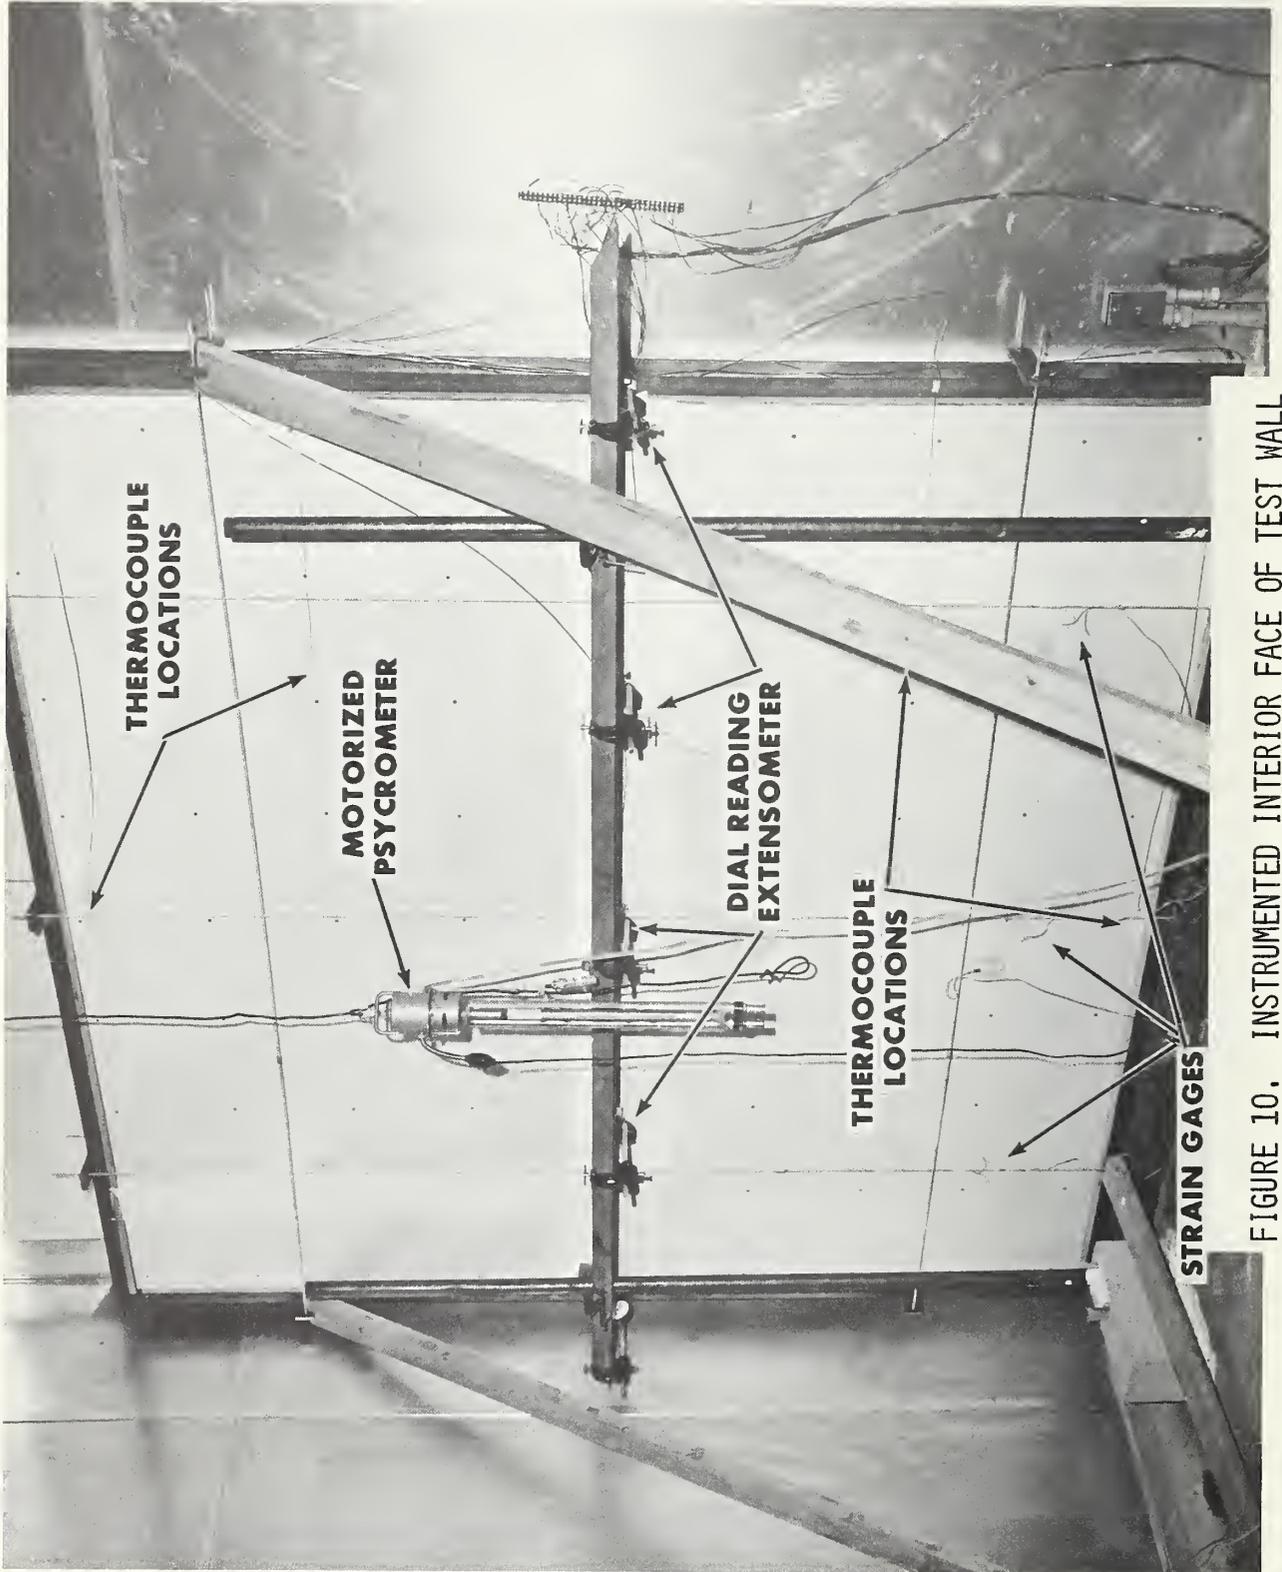
FIGURE 10. INSTRUMENTED INTERIOR FACE OF TEST WALL

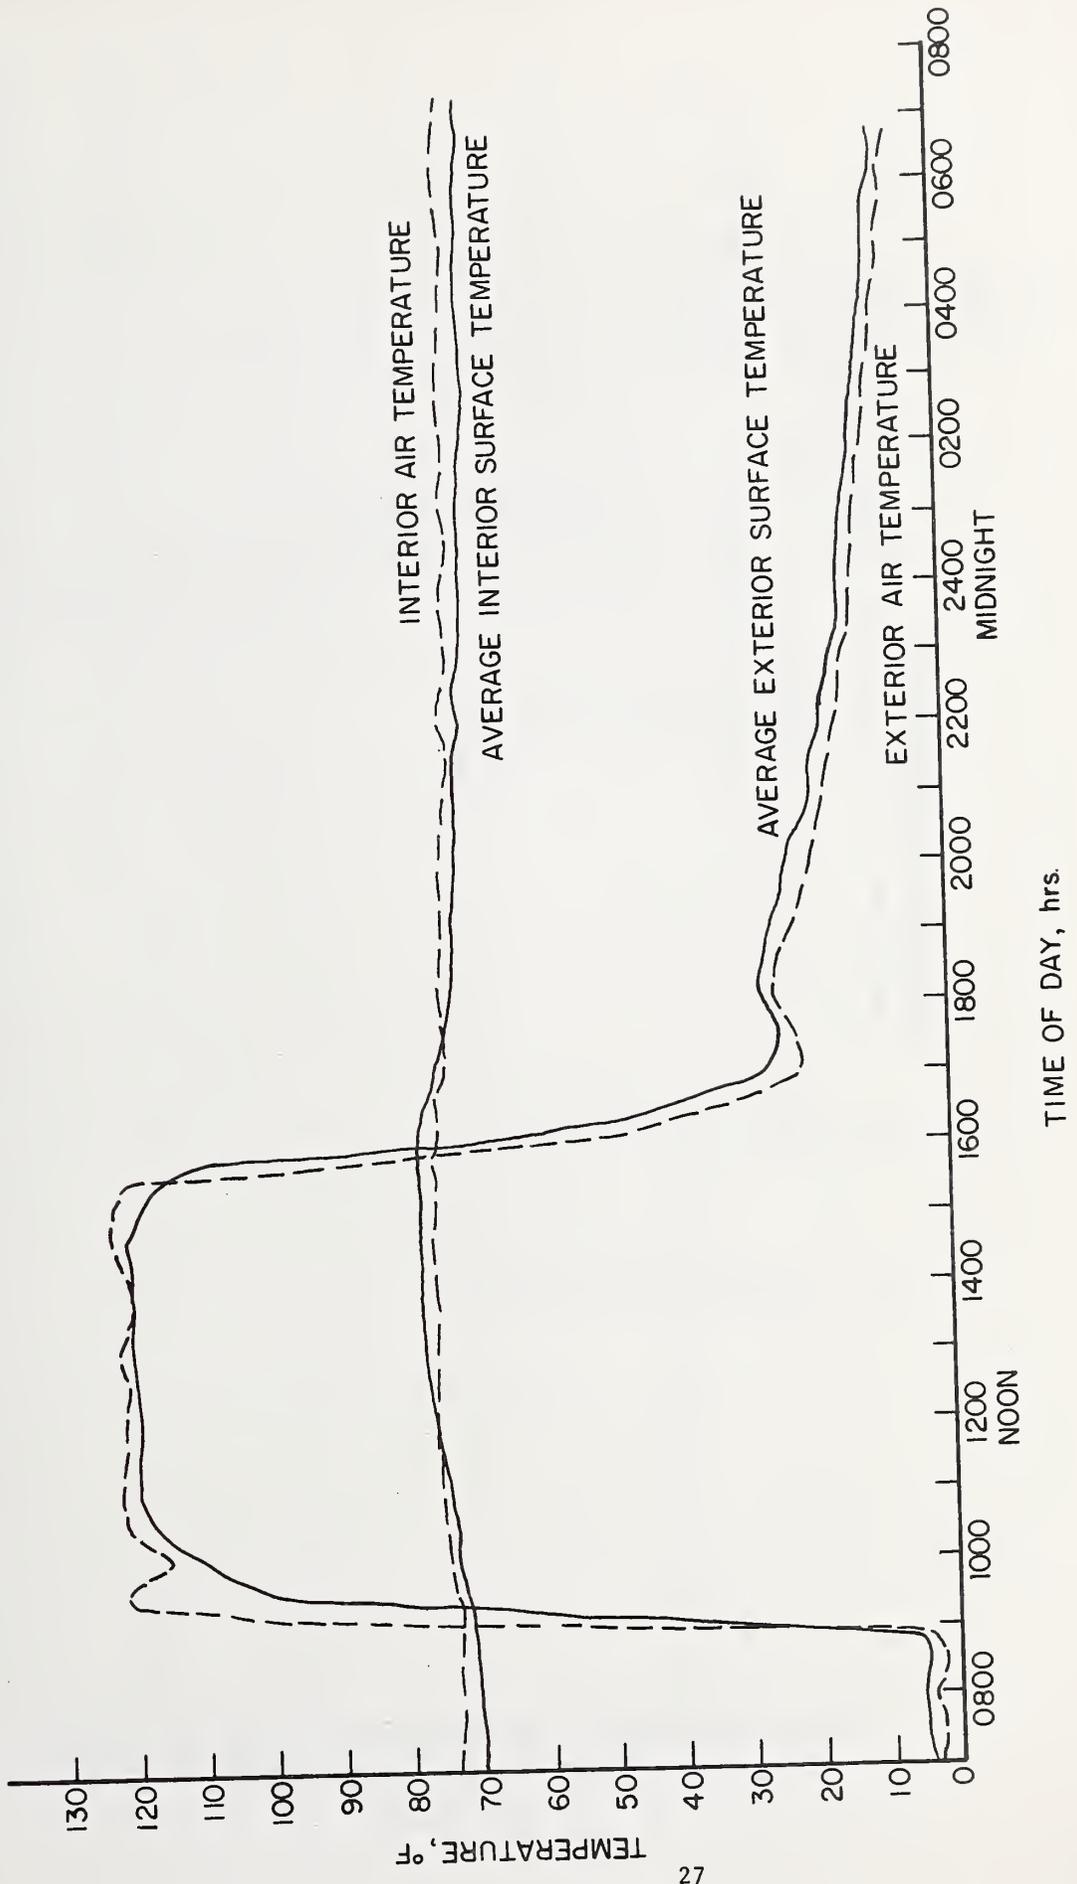
FIGURE 11. AIR AND SURFACE TEMPERATURES DURING TYPICAL 24 HOUR THERMAL CYCLE

at the high temperature and a 16 hr period at the low temperature. A plot of the air temperature and average wall surface temperature for both the interior and exterior sides during a typical cycle is shown in figure 11. Figure 12 exhibits the maximum and minimum surface temperatures on the exterior face during the 30 day test period. The relative humidity in the test chamber to which the exterior side was exposed varied during the cycle from 50% in the low temperature segment to 20% in the high temperature segment.

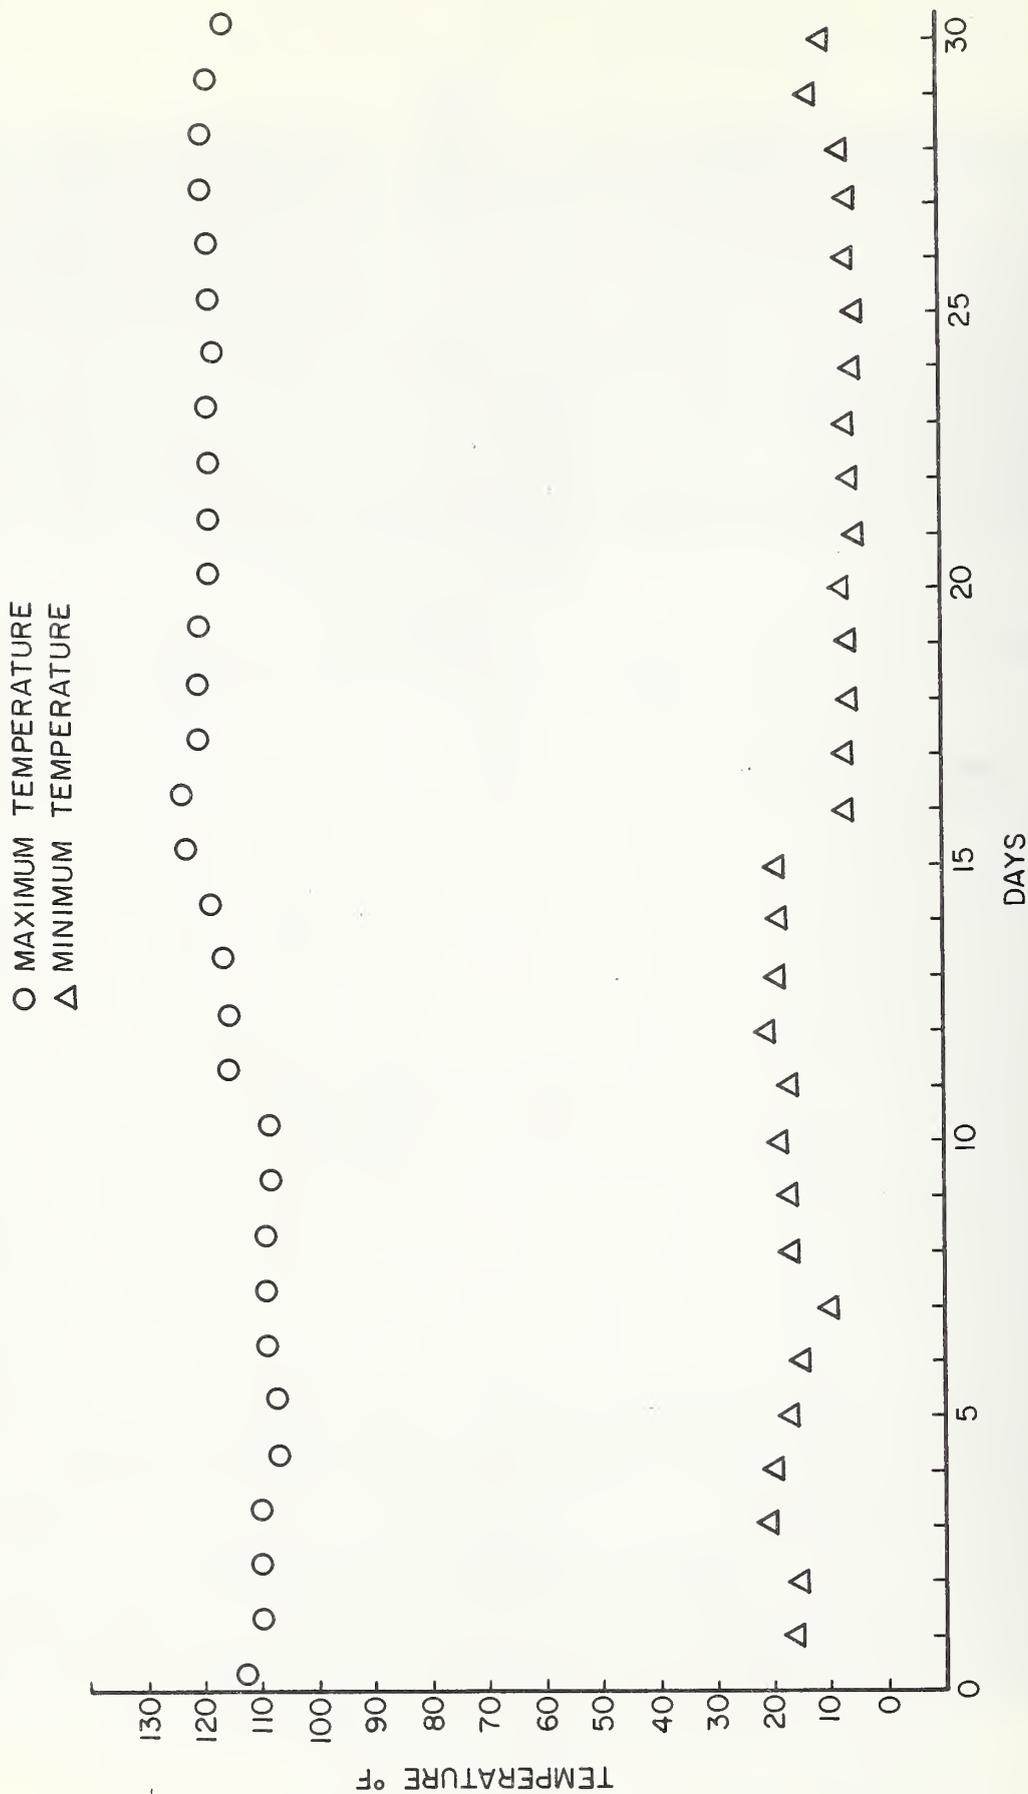
FIGURE 12. MAXIMUM AND MINIMUM SURFACE TEMPERATURES DURING TEST PERIOD
